FIRE STATION ASSESSMENT SUMMARY- RECOMMENDATION

ASSESSMENT REPORT- WESTMORELAND FIRE STATION

WESTMORELAND FIRE STATION, located at 772 NH Rte. 63.

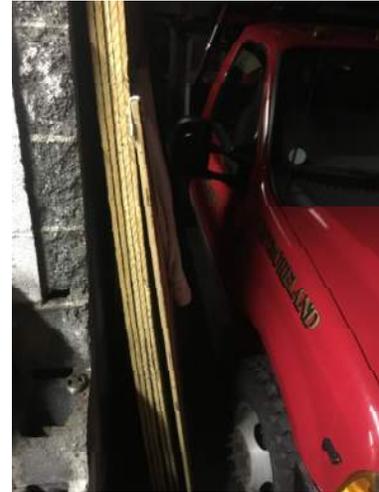
The current trucks are literally shoe-horned into the building.

THE BAYS ARE TOO NARROW, TOO SHORT, AND TOO LOW.

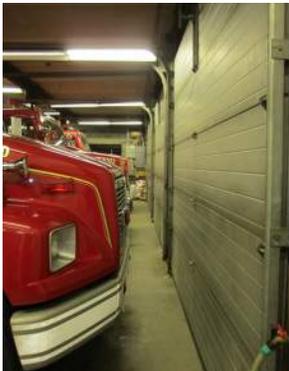
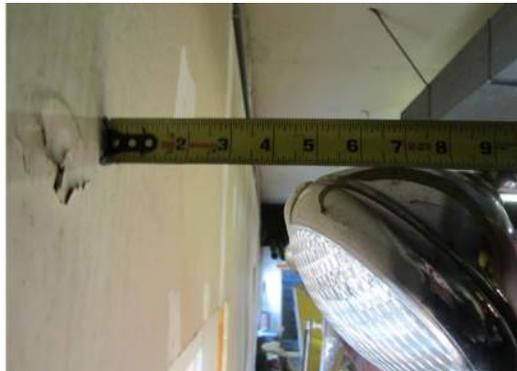
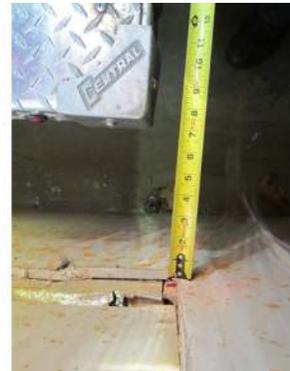
There is not adequate circulation around the trucks, or from one bay to another. Typically there is about 12'-14" from the columns and less than 10" clear for the lights and mirrors.

The bays are so narrow that the trucks, and specifically their mirrors, are in jeopardy every time they are backed into place.

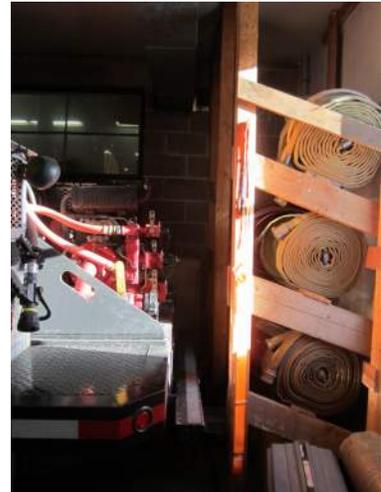
The existing hose racks are inadequate and inaccessible.

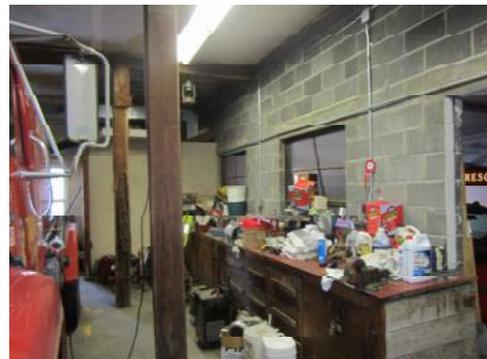
There is no work room to repair equipment and store items such as Speedy Dry. There is an inadequate bench serving as a work room.

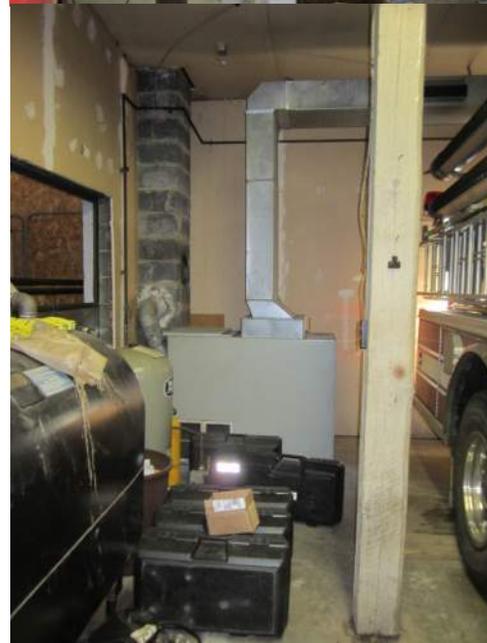
- The oil fired furnace is in the open immediately adjacent to one of the trucks.

- The current stair to the second floor and also to the western most bay does not have proper number and configuration of handrails.
- The furnace (assuming it is rated for over 400,000 BTU/Hr should be separated from the remainder of the building with a 1-hour fire rated enclosure,

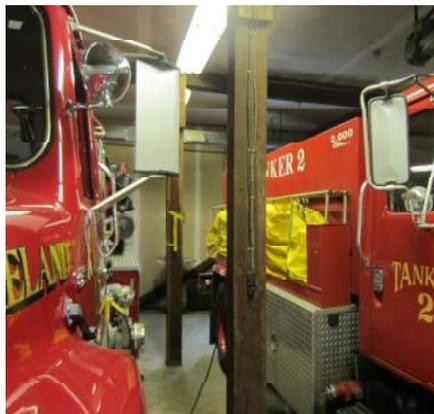
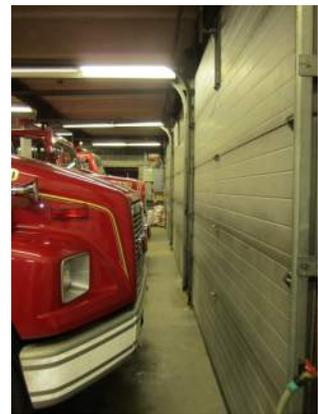
- The current clear exit width is less than 36 inches in many locations. This includes between the trucks and first floor columns and particular along the main egress pathway along the north side (along the overhead doors) of the building. In fact the clearance in the western most truck bay, where the only exit door is located is less than 12 inches (Overhead doors are not considered exits only swing type can be

used for exits).

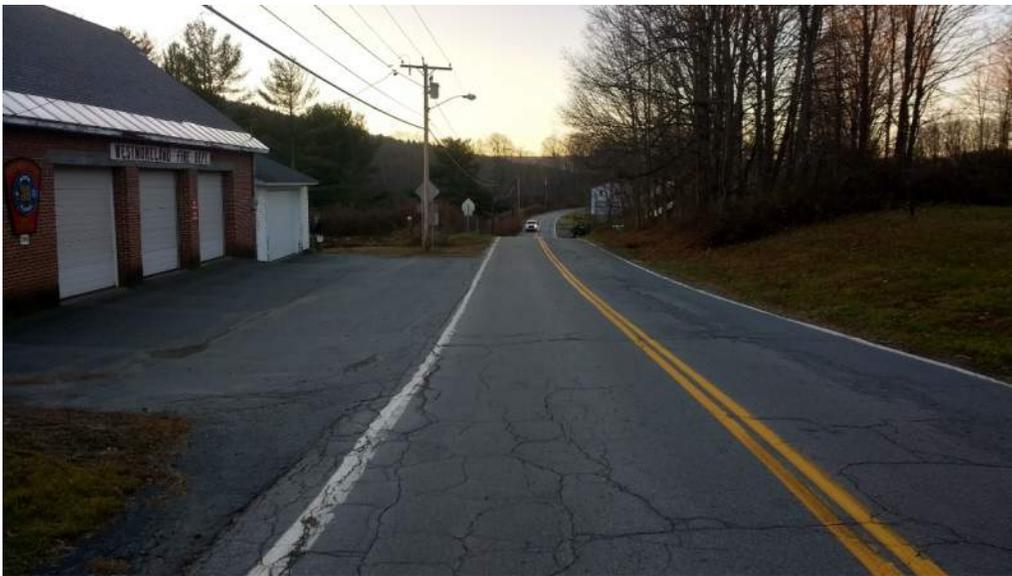
- **Lot Size-** 0.33 +/- acres
- **Site Access and Apron** – The property is accessed through a wide open frontage with no defined entrances. There is parking for firemen on the east side of the site in the lot shared with the town hall and the post office. The front apron is approximately 24 feet from the building to the travel lane and Route 63. The length available to safely park fire trucks away from the travel lane and leaving space between the doors is approximately 20 feet. All of the town fire trucks are over 21 feet long. Therefore the existing apron is not sufficient to park fire trucks for cleaning or washing the trucks. This also requires the traffic to be halted in Route 63 to back trucks into the station.

Apron at front of station.

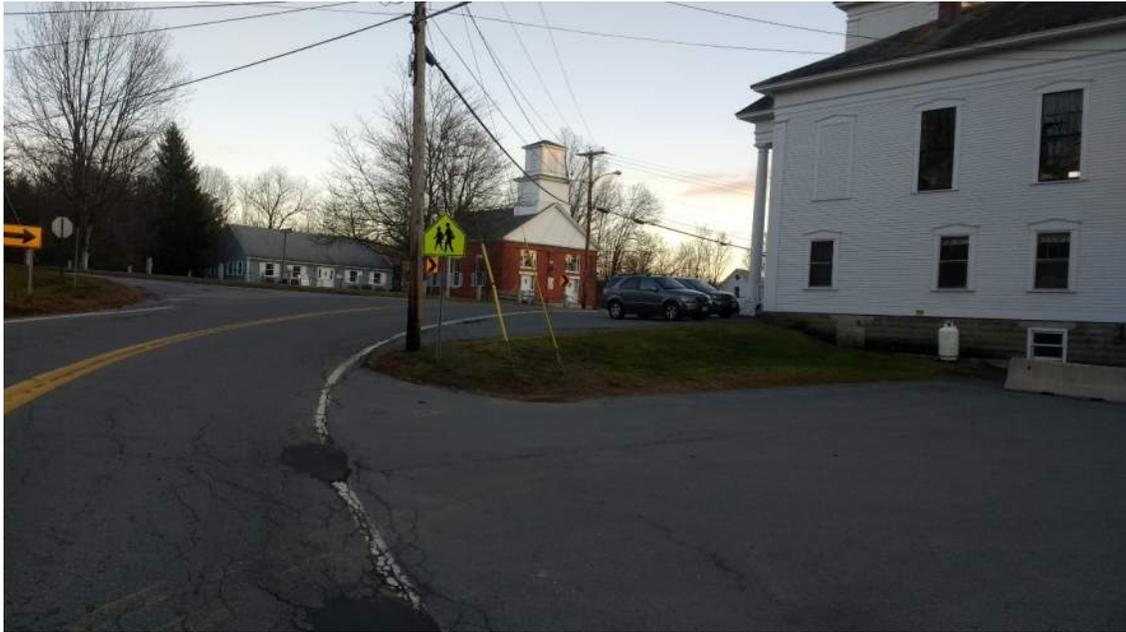
- **Sight Distance on Route 63** – The speed limit on this section of Route 63 is 30 miles per hour. The sight distance to the west is good at approximately 600 feet. Sight distance to the east from the eastern most bay is poor at less than 160 feet and is further limited by vehicles parking at the town hall and in the lot adjacent to the town hall. NH DOT requires a minimum of 400 feet all season sight distance for driveway entrances onto state highways.

Sight distance along 63 looking east.

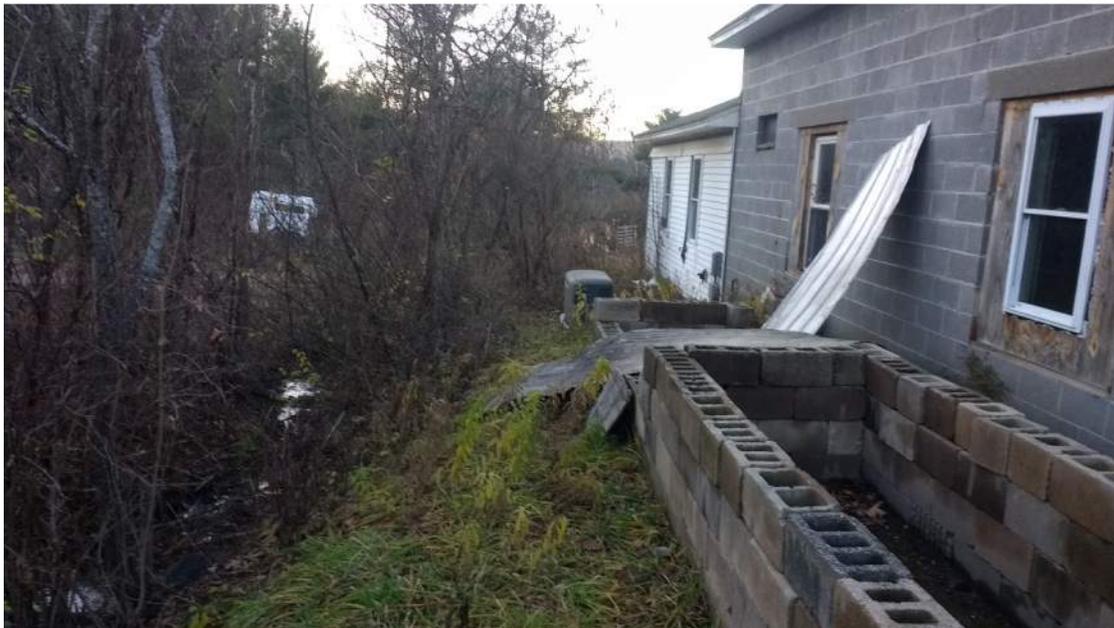
- **Topography** – The lot slopes to the west along Route 63. A retaining wall was constructed adjacent to the parking lot at the town hall to compensate for grade difference when the last addition was added to the building.
- **Uplands/Wetlands** – There is a seasonal brook that crosses under Route 63 and is culverted under the parking lot between the fire station and the town hall. The brook then travels behind the fire station very close to the rear wall. The proximity of the brook to the building is causing moisture problems within the building due to high ground water. The location of the brook on two sides of the building also limits the future expansion potential of the building.

Rear of fire station – Brook can be seen on left side of picture.
