FIRE STATION ASSESSMENT SUMMARY- RECOMMENDATION

ASSESSMENT REPORT- WESTMORELAND FIRE STATION

WESTMORELAND FIRE STATION, located at 772 NH Rte. 63.

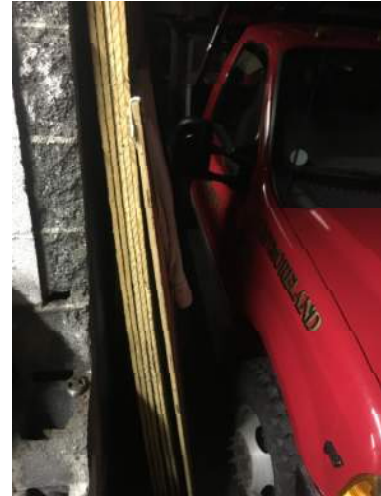
The current trucks are literally shoe-horned into the building.

THE BAYS ARE TOO NARROW, TOO SHORT, AND TOO LOW.

There is not adequate circulation around the trucks, or from one bay to another. Typically there is about 12'-14" from the columns and less than 10" clear for the lights and mirrors.

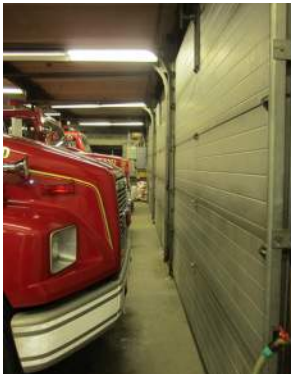
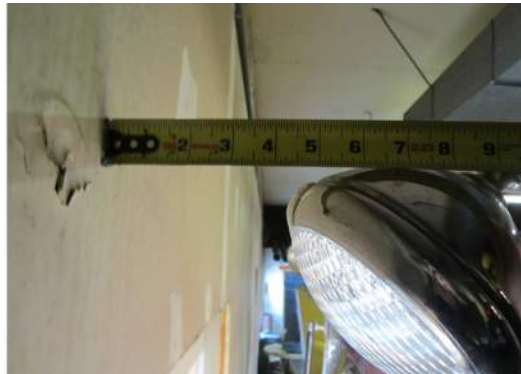
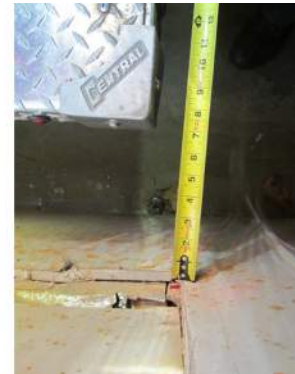
The bays are so narrow that the trucks, and specifically their mirrors, are in jeopardy every time they are backed into place.

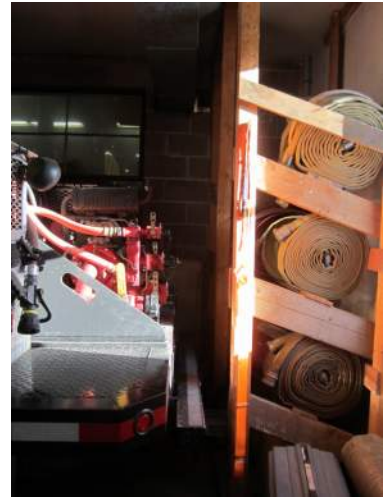
The existing hose racks are inadequate and inaccessible.

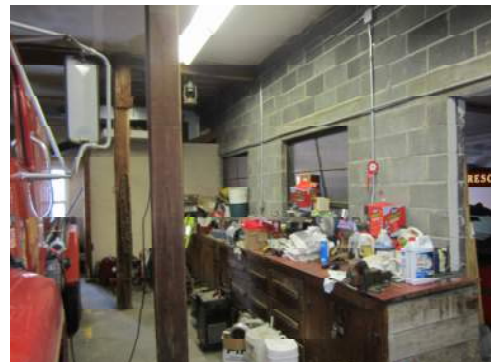
There is no work room to repair equipment and store items such as Speedy Dry. There is an inadequate bench serving as a work room.

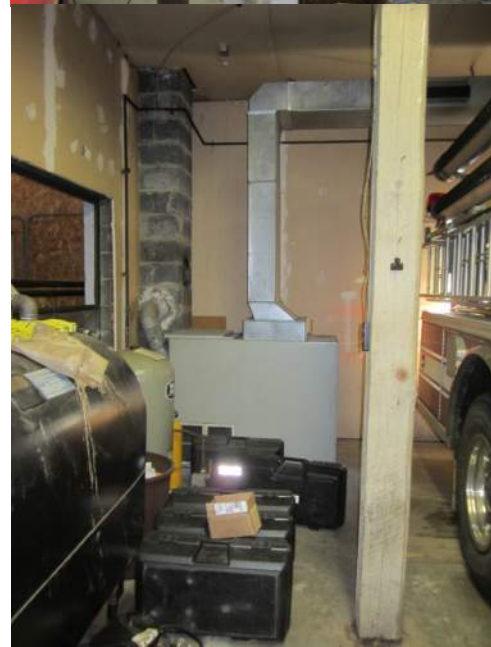
- The oil fired furnace is in the open immediately adjacent to one of the trucks.

- The current stair to the second floor and also to the western most bay does not have proper number and configuration of handrails.
- The furnace (assuming it is rated for over 400,000 BTU/Hr should be separated from the remainder of the building with a 1-hour fire rated enclosure,

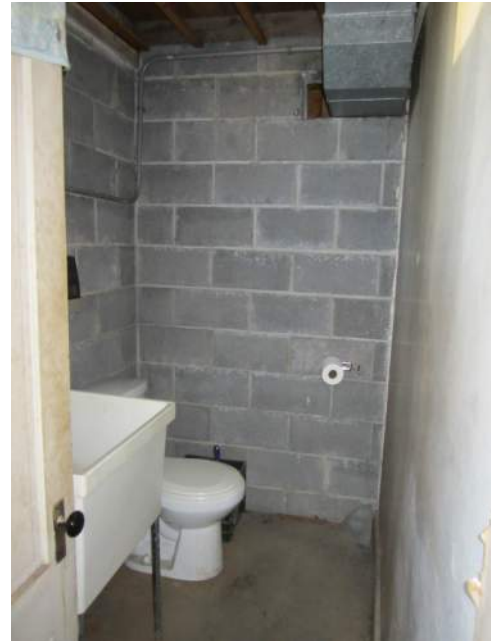
- The existing toilet facility is essentially a closet with a toilet and janitor's slop sink. This is not a healthy mix and is too small.
- There is no pretense of ADA accessibility
- There is no shower facility.
- There is no eye-wash system
- There is no rapid fill system to re-load the tanker trucks.

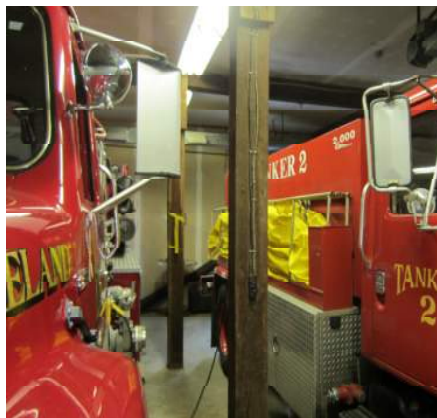
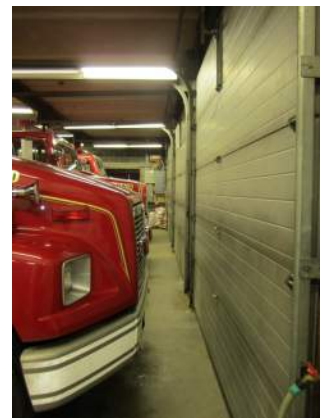
- The current clear exit width is less than 36 inches in many locations. This includes between the trucks and first floor columns and particular along the main egress pathway along the north side (along the overhead doors) of the building. In fact the clearance in the western most truck bay, where the only exit door is located is less than 12 inches (Overhead doors are not considered exits only swing type can be

used for exits).

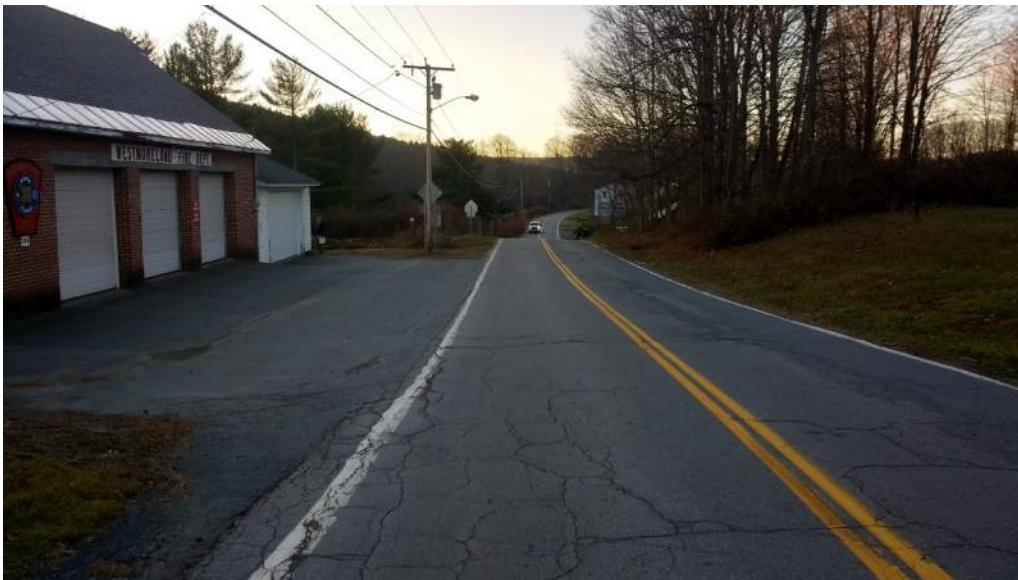
- **Lot Size-** 0.33 +/- acres
- **Site Access and Apron** – The property is accessed through a wide open frontage with no defined entrances. There is parking for firemen on the east side of the site in the lot shared with the town hall and the post office. The front apron is approximately 24 feet from the building to the travel lane and Route 63. The length available to safely park fire trucks away from the travel lane and leaving space between the doors is approximately 20 feet. All of the town fire trucks are over 21 feet long. Therefore the existing apron is not sufficient to park fire trucks for cleaning or washing the trucks. This also requires the traffic to be halted in Route 63 to back trucks into the station.

Apron at front of station.

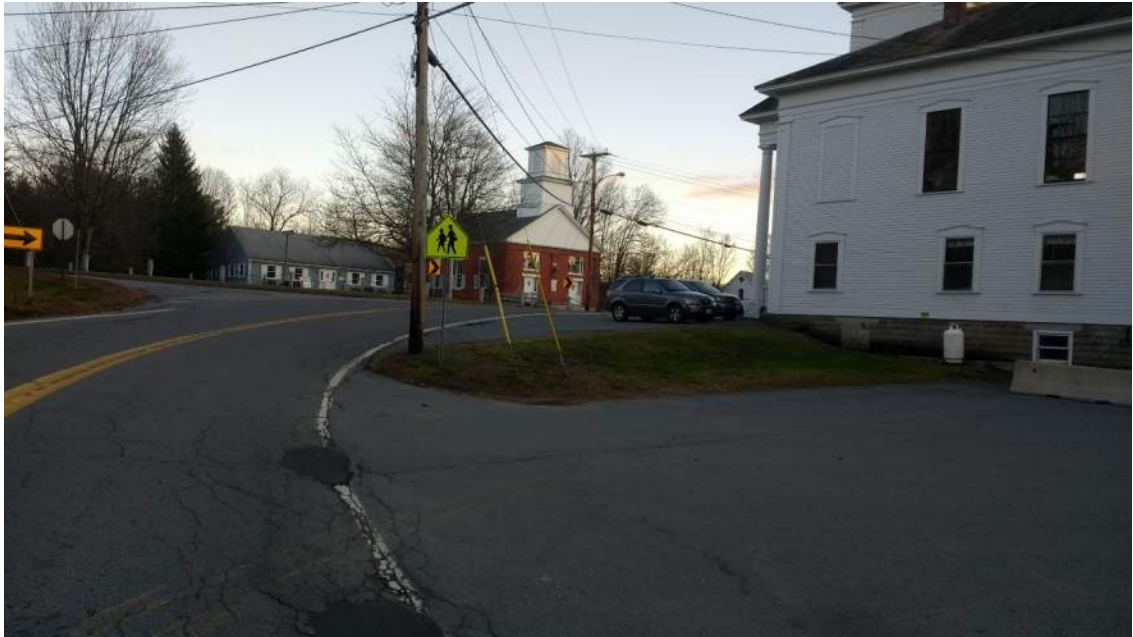
- **Sight Distance on Route 63** – The speed limit on this section of Route 63 is 30 miles per hour. The sight distance to the west is good at approximately 600 feet. Sight distance to the east from the eastern most bay is poor at less than 160 feet and is further limited by vehicles parking at the town hall and in the lot adjacent to the town hall. NH DOT requires a minimum of 400 feet all season sight distance for driveway entrances onto state highways.

Sight distance along 63 looking east.

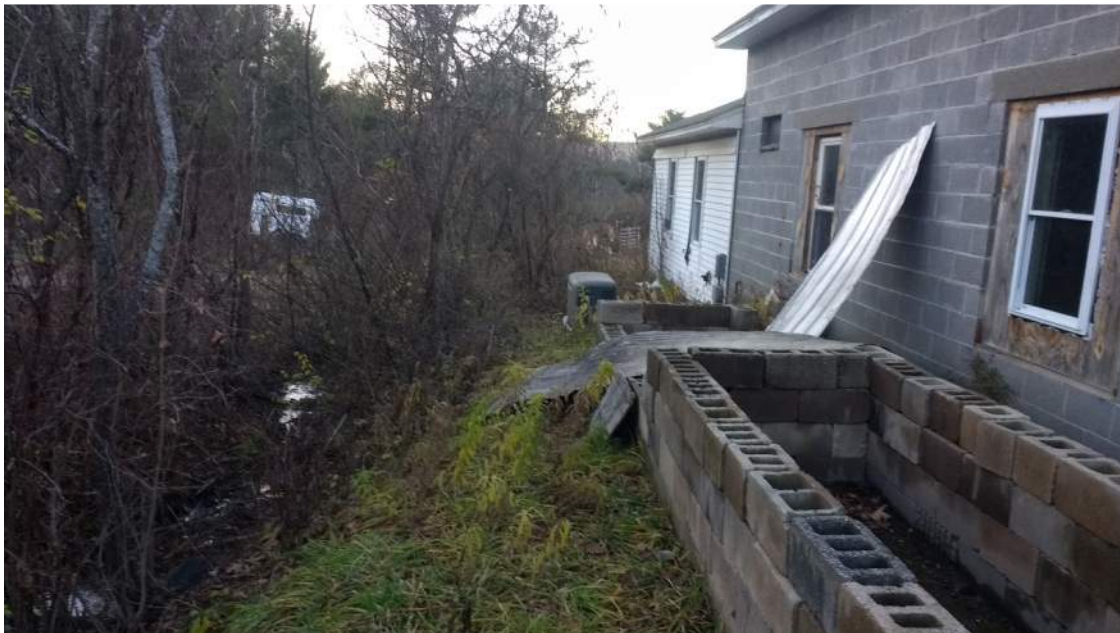
- **Topography** – The lot slopes to the west along Route 63. A retaining wall was constructed adjacent to the parking lot at the town hall to compensate for grade difference when the last addition was added to the building.
- **Uplands/Wetlands** – There is a seasonal brook that crosses under Route 63 and is culverted under the parking lot between the fire station and the town hall. The brook then travels behind the fire station very close to the rear wall. The proximity of the brook to the building is causing moisture problems within the building due to high ground water. The location of the brook on two sides of the building also limits the future expansion potential of the building.

Rear of fire station – Brook can be seen on left side of picture.
